Newark Flat Crossing Renewal

TECHNICAL ARTICLE

The PWI Journal
April 2020

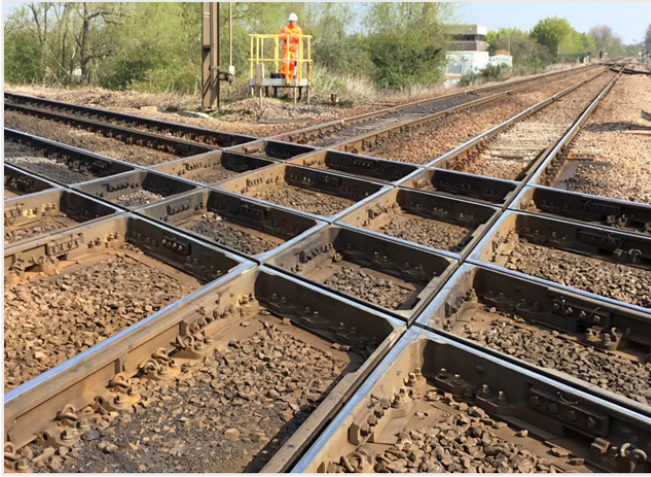
Image 1: Newark flat crossing overview

Newark flat crossing is a junction on the East Coast Mainline (ECML 120ml 63ch) just north of Newark Northgate station that intersects the Newark to Lincoln line (NOB1 17ml 74ch). See image 1.

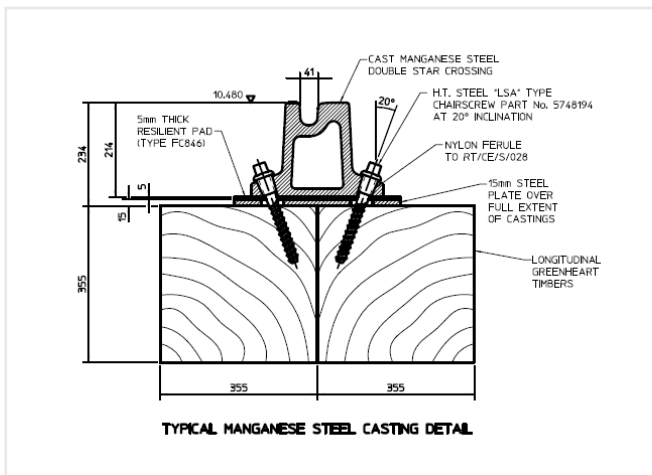
Figure 1: 2003 layout crossing fastening system.

The crossing foot was manufactured so that the LSA screws were installed at an angle of 1 in 20 to the vertical plane, as shown in figure 1. It was thought that having two screws on opposite sides of the casting inclined at this angle toward the centre of the casting would provide a more secure method of 'pinning' the castings in position and therefore prevent lateral movement of the crossings occurring. The holes that were drilled in the crossing foot were larger than the corresponding screw shank by some margin. This gap was filled by using a nylon ferrule. Over time the lateral forces applied to the crossings through to the fastening system crushed and wore away the nylon ferrules. This allowed lateral movement to develop at the interface between the crossing foot and the screws.

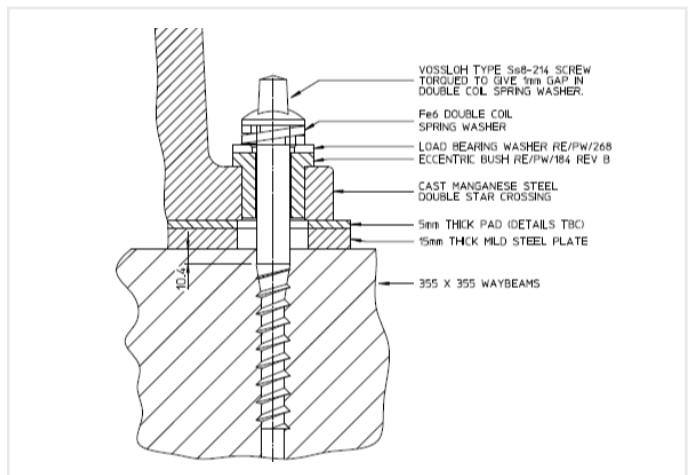
Figure 2: Revised crossing fastening system.

I got involved with Newark flat crossing at this point to lead the work to resolve the crossing foot design problem. This was redesigned in 2015 to have a vertical screw with an eccentric steel ferrule (figure 2) to allow for the possibility of screw holes being drilled off centre to the crossing foot hole centre. To avoid the screw holes of the new crossings clashing with broken screws still in place in the bearers from the old crossing screws, the position of the holes in the cast crossing foot were offset by 50 mm.

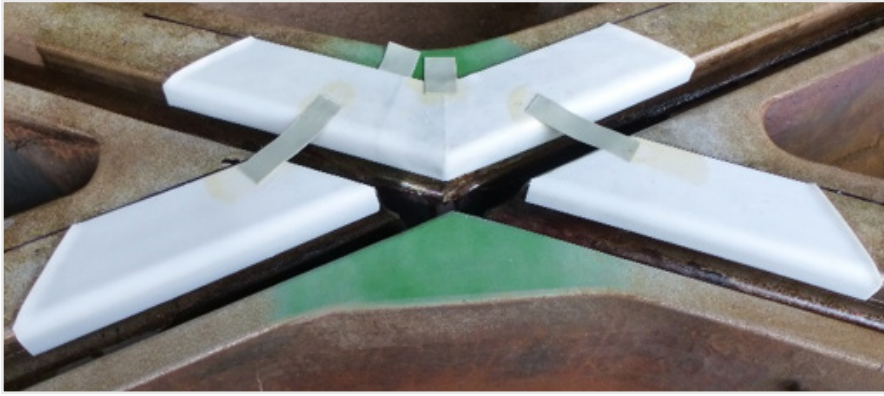
Image 2: Strips of explosive in place in preparation for EDH.

The EDH process involves laying a thin layer of explosive on the area to be hardened (image 2) and detonating it. This has the effect of compressing and hardening a thin layer of the crossing surface. This hardening helps reduce the amount of plastic deformation that occurs on austenitic manganese steel (AMS) crossings during the initial running of traffic over them. The running surface of AMS crossings is relatively soft until some traffic tonnage has run over it. The area of the double star crossings where EDH was used was restricted to the crossing nose and wing rail of the wheel transfer area. Increasing this for all running surfaces would have risked damaging or destroying the casting during the EDH process.

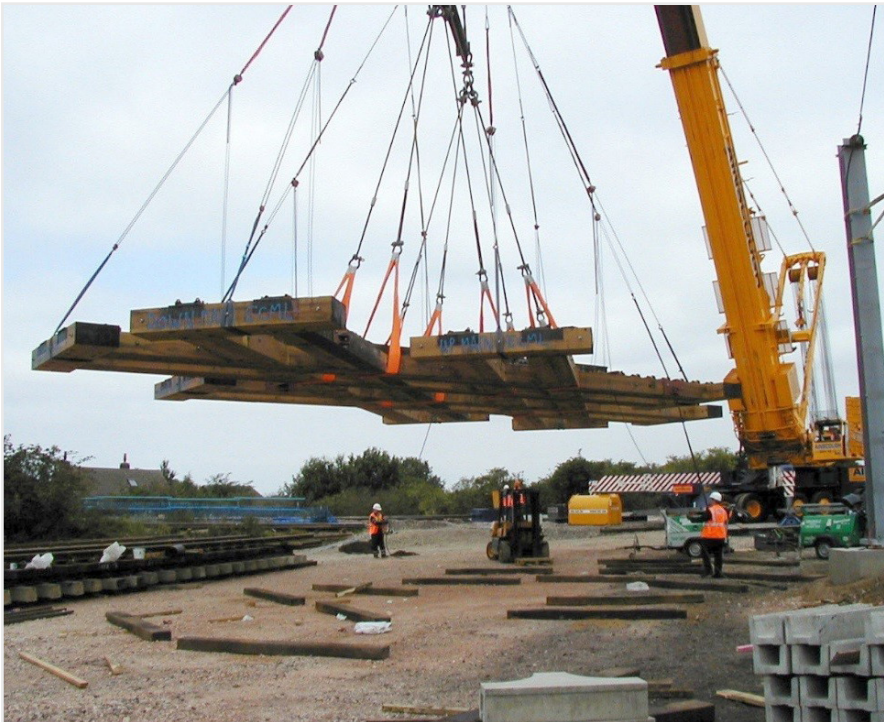
Image 3: The 2003 renewal being installed using a large road crane.

The layout was last renewed in 2003, see image 3. The main driver for the 2019 renewal was the poor condition of the ballast under the bearers; the bearer condition had started to deteriorate and the track quality was in the super red band.

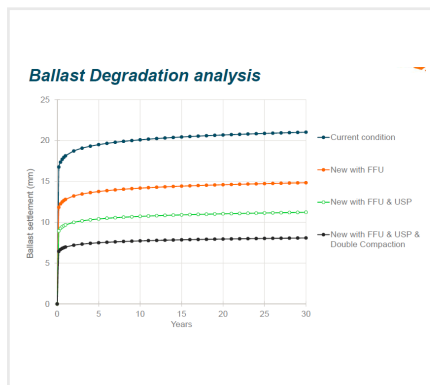
Figure 4: Ballast degradation analysis.

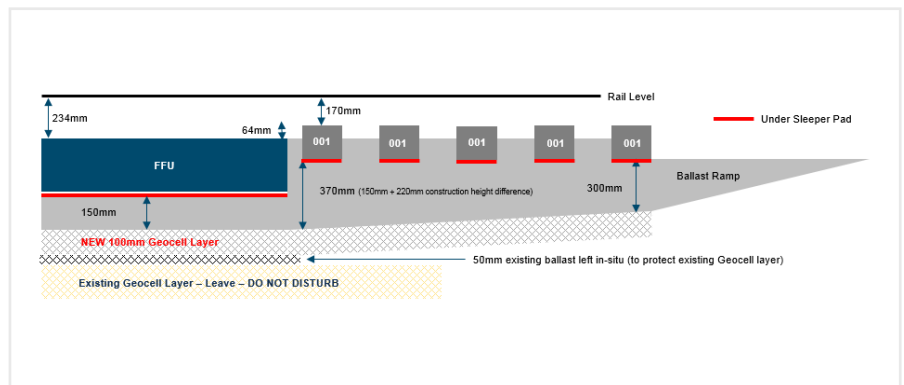
Figure 5: Selected track bed design.

The selected track bed design shown in figure 5 required.

- Under sleeper pads to reduce ballast deterioration, especially in the 'top' layer.
- Ballast compacted in two layers.
- Additional geocell layer on top of existing geocells to minimise ballast deterioration in 'bottom' layer.
- High accuracy of installation.
- Understanding that deterioration is expected as it is a ballasted system and settlement cannot be entirely eliminated.

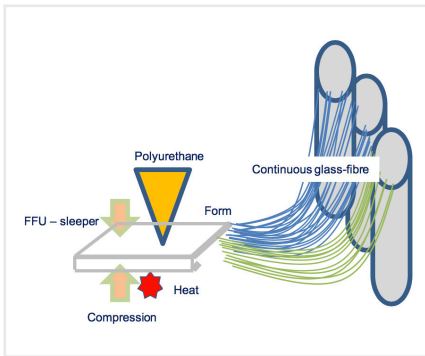
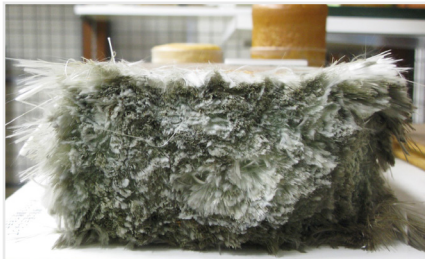
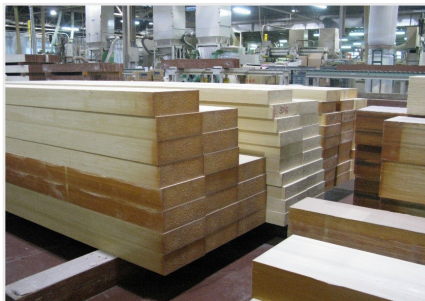
Figure 6: Pultrusion process and the finished material.

FFU is a material made from a glass fibre and polyurethane composite (figure 6). The material is manufactured by a pultrusion process in 30 mm thick lengths that are then layered to achieve the product height required. The layers are bonded together with an adhesive forming a very strong composite structure.

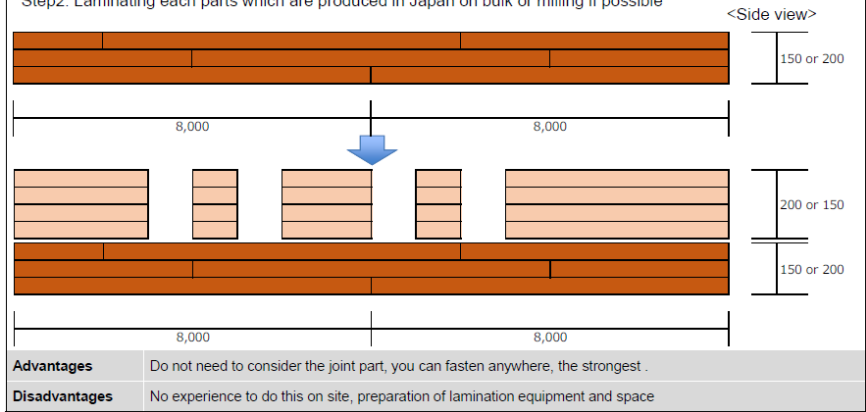
Figure 7: Cross-section of the FFU bearer.

the Progress Rail team assembling and gluing the 30 mm thick layers of FFU together in a lattice pattern under the supervision of Sekisui engineers to form the bearer lengths required (see figure 7).

The main body of the bearers was specified as FFU74 (740 kg/m³) with a top layer of higher density FFU 100 (100 kg/m³). This was to add further resilience to the bearer surface for possible long-term attrition from the crossing componentry. This work was made even more interesting as the Sekisui engineers did not speak English, so all communication had to be done through an interpreter. Despite this challenge, the Progress Rail team worked extremely well with the Sekisui engineers to make each of the bearers in the planned timescale.

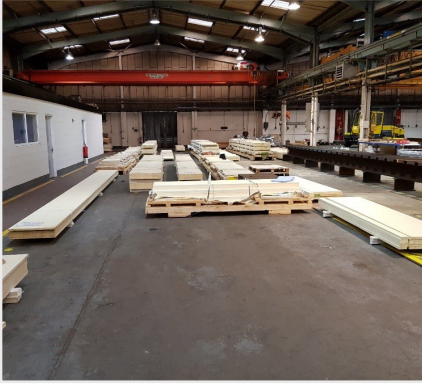
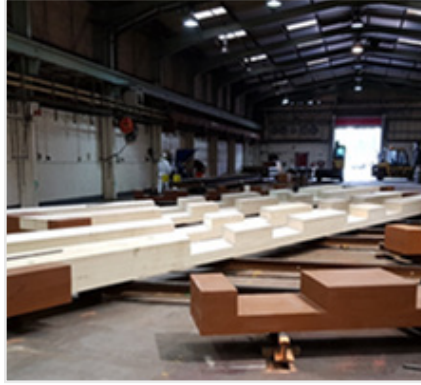
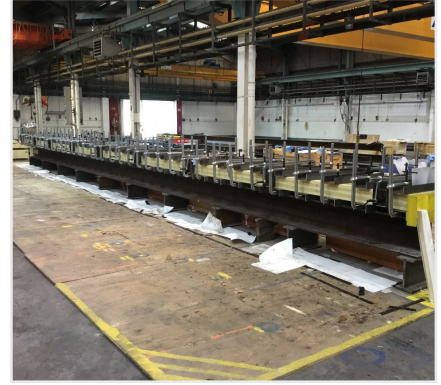
Images 4a, 4b, 4c: Manufacture of the FFU bearers.

Once the bearers had been successfully manufactured, see images 4a, 4b and 4c, the beams were assembled to form the bearer matrix for the layout. See image 5. It was decided, after consultation with the Sekisui engineers, to mirror the assembly of the timber bearers by adding bolts through the beam sections at the same positions as the previous timber bearers as an additional method of securing the composite layers together. This was in addition to the bolts that would be used to fasten the 16 joints where the bearers overlap.

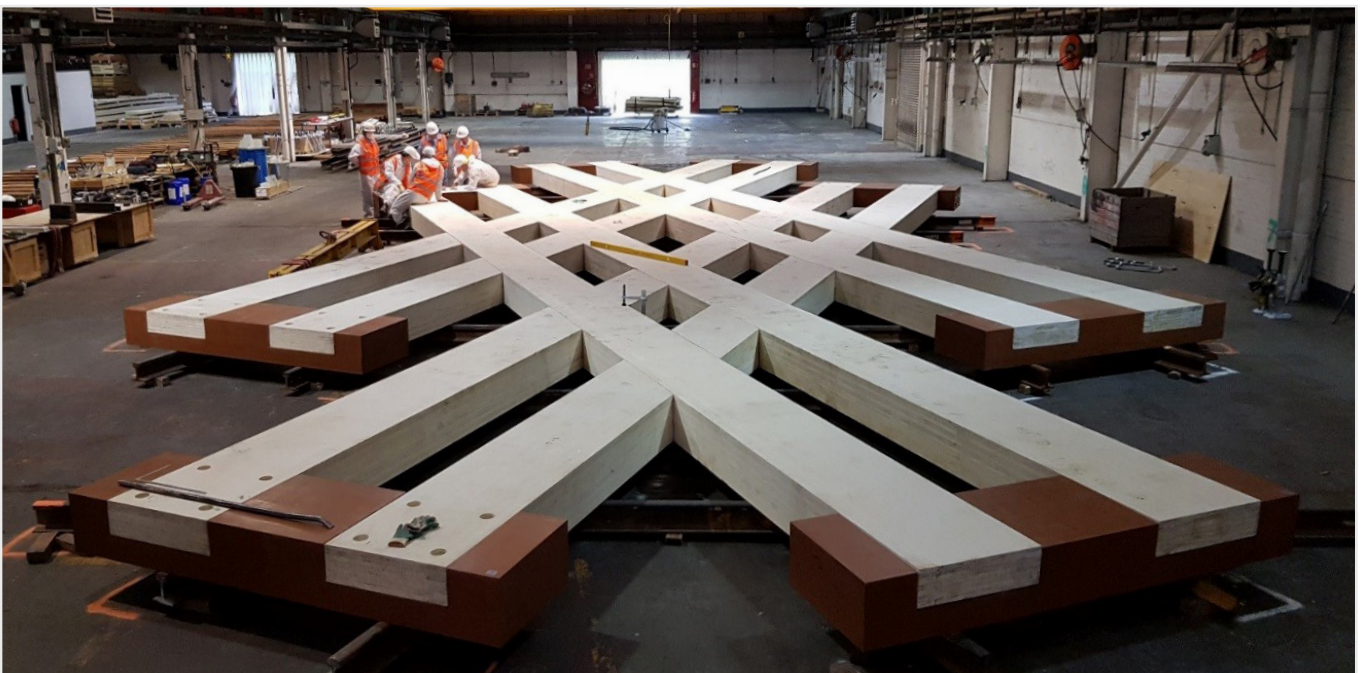
Image 5: The completed FFU bearer layout.

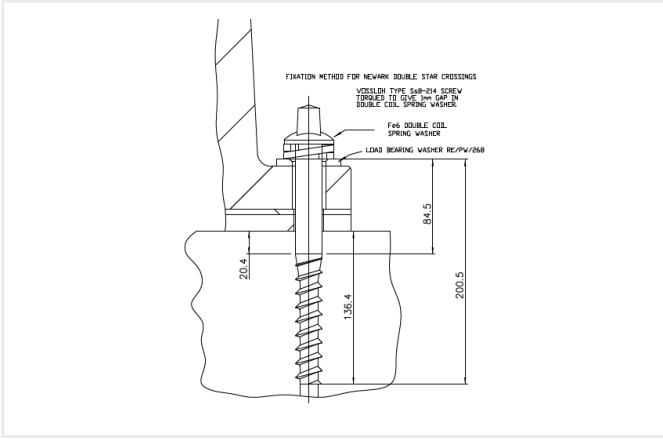
Figure 8: The crossing foot fastening system of the 2019 installation.

The main improvement was to remove the need for an eccentric ferrule as a component of the crossing foot fastening system. To do this the diameter of the hole drilled in the foot of the casting was reduced to be slightly wider than the adjacent screw shank. This has resulted in a much tighter tolerance between the crossing foot and screw shank dimension. The removal of the eccentric ferrule has also lowered the overall height dimension of the previous crossing foot/ferrule/screw combination. This has allowed an additional 10 mm of the screw shank to be in the bearer, improving the ability of the screw to resist lateral movement in service.

Figure 8 shows the revised crossing foot fastener system that is now installed on the newly installed layout.

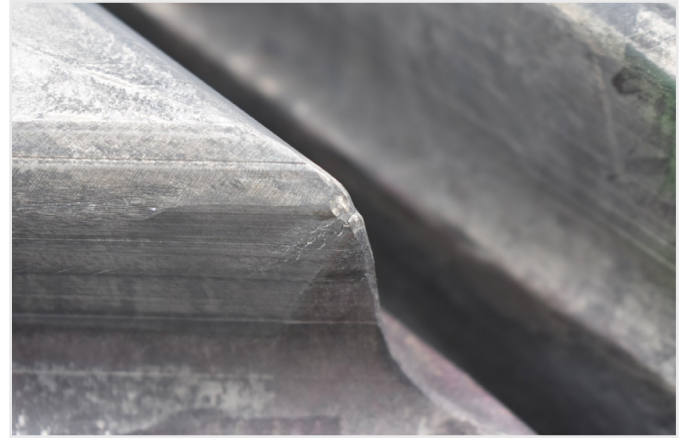
Image 6: Cracking on the crossing nose after EDH.

The intention was to supply EDH'd crossings for the renewal similar to the 2015 crossings previously installed. However, during the manufacturing of the first two crossings for the layout, some small cracks were found in one of the crossing noses after EDH had been carried out. See image 6.

The reason behind this was unclear at the time. There was a high risk that the other remaining six double star crossings could suffer the same problem if EDH was applied. There would not be enough time to produce additional castings and meet the timescales required by the project for the installation dates.

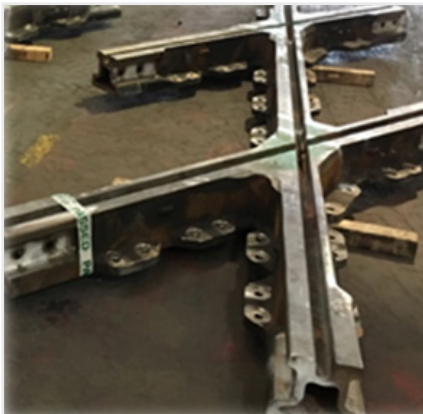
Image 7a: Double star crossing.

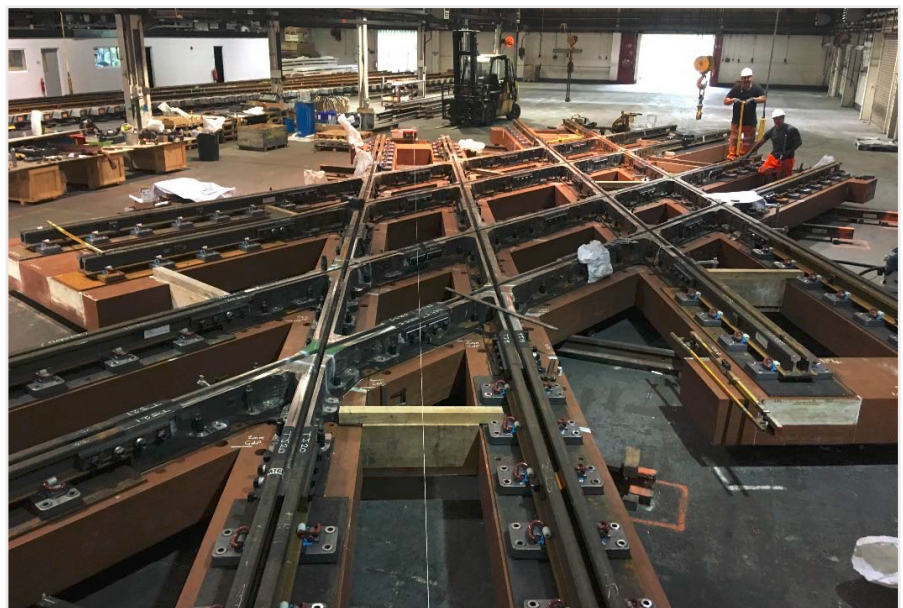
Image 7b: Installed on the layout.

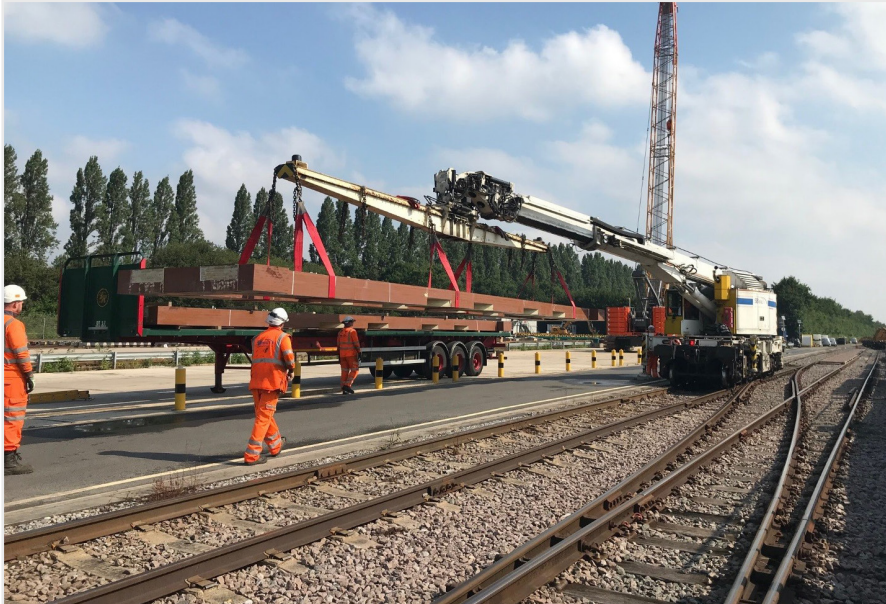
Image 8a: Double bearer sections being lifted onto rail wagons.

Once at the rail head, the bearer sections were lifted from the trailers onto rail wagons by a Kirow crane using a spreader beam, see image 8a. This was also done to avoid placing stress on the bearers' sections and potentially damaging or distorting them which could have prevented them being reassembled successfully at the construction site. This lifting operation was repeated when the sections were unloaded at the site and the bearer matrix reassembled.

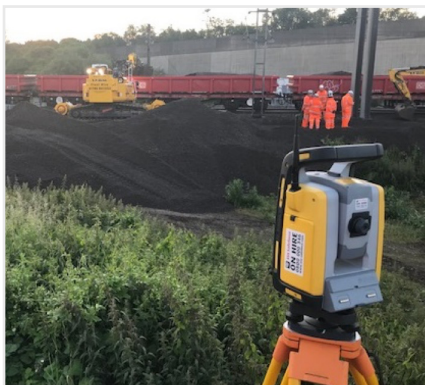
Images 9a, 9b, 9c: Build area created next to the junction.

To enable the layout to be assembled on site, additional work was required by the newly formed Central Rail Systems Alliance (CRSA) to create a flat build area where the components could be re-assembled. See images 9a, 9b and 9c. This involved unloading and levelling over 200 tonnes of spoil to create an area next to the junction that was at the same height as the adjacent track, which left quite an embankment! This was regraded after the completion of the renewal and the boundary fencing reinstated.

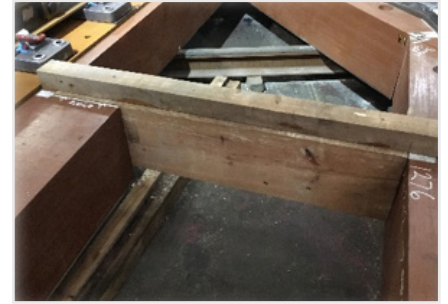
Image 8b: The spacer block.

the whole section could potentially squeeze the two bearer lengths together which could distort or damage them. To mitigate against this happening, a wooden 'T' section spacer was made and placed in between each double bearer section during lifting operations. See image 8b.

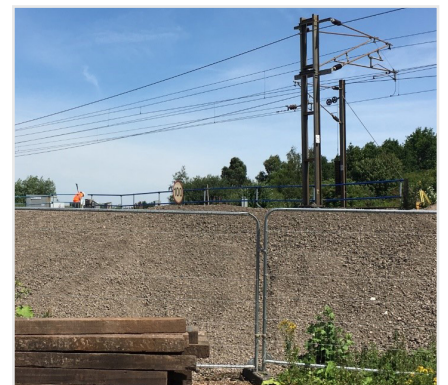
Image 10: Bearer beams being unloaded and re-assembled on site.

Once the site had been prepared the double bearer beams were delivered, unloaded and re-assembled (see image 10). The re-assembly of the layout was carried out by Progress Rail for the project. This made perfect sense as the Progress Rail team had assembled the layout in the warehouse, and so had the experience and technique of fitting it together again. They were also aware of the importance of the correct re-assembly of the composite bearers. Giving this task to the CRSA team would have added another risk to the project as they had no experience in assembling such a complex layout.

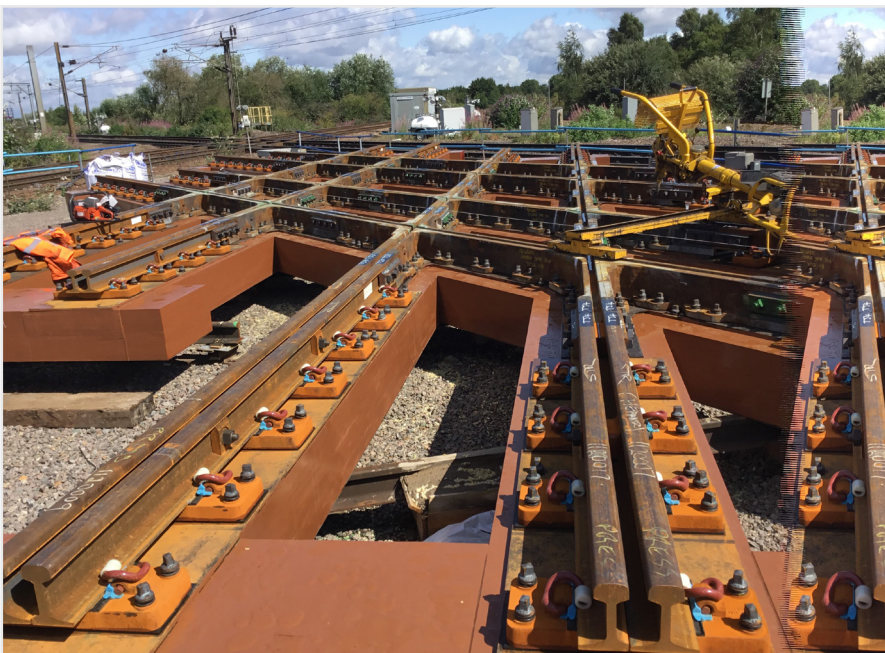
Image 11. Check rail extensions with thickened UCV rail baseplates and Pandrol® e-Plus clips.

This is a stronger cast iron than the previous grey iron check baseplates. The stronger cast iron baseplates enabled a higher toe load rail clip to be used, in this case a Pandrol® e-Plus clip. The higher toe load clip will help mitigate against rail movement due to seasonal ambient temperature variations.

The only difference to the standard UCV check baseplate that is used in NR56V S&C was that to enable the rail to be at the same height as the double star crossings running surface

the UCV baseplate rail seat needed to be thickened, see image 11.

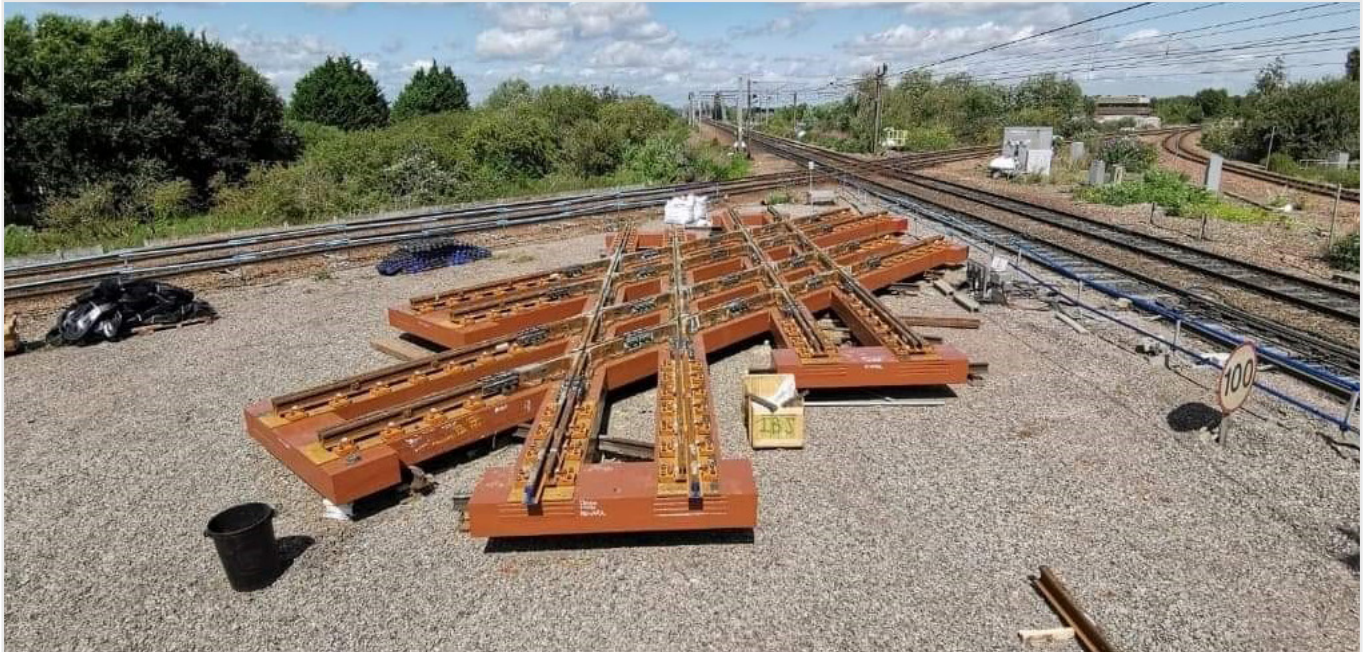
Image 12: The assembled layout awaiting installation.

The hard work from the Progress Rail team who re-assembled the layout is clear to see as shown in image 12, with the layout completed and ready for installation on time.

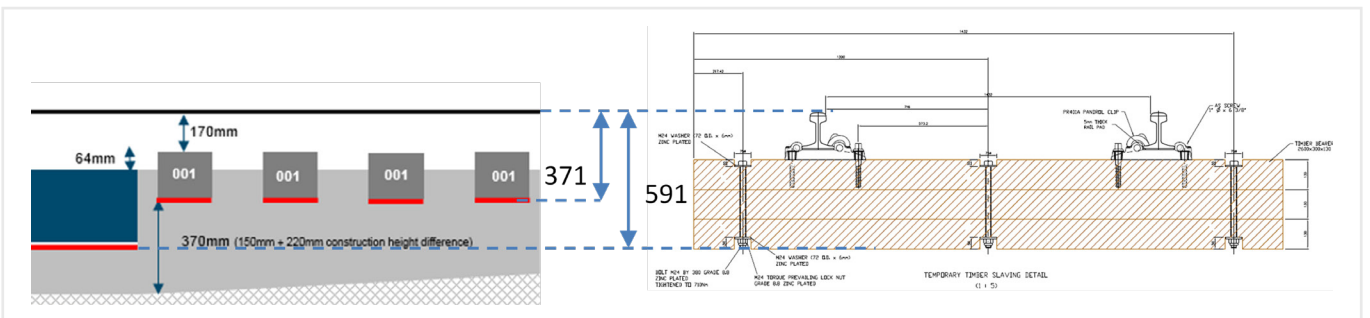
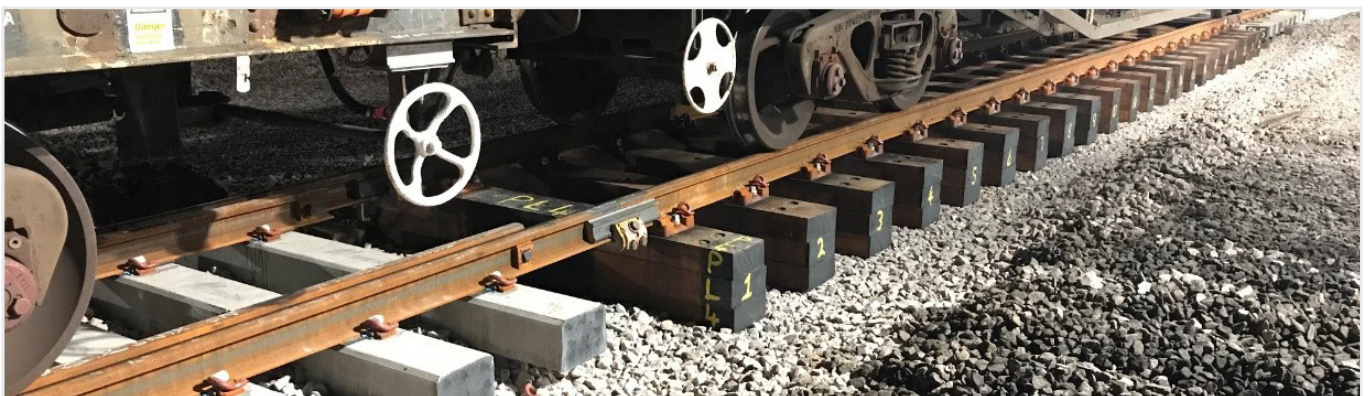
Figure 10: Slave panel design to level rail heights during the installation.

Due to the depth of the bespoke bearers (350 mm) combined with the additional height of the crossings, the new ballast bed was much lower than usually found on a track renewal. This meant that a simple short panel of track would not be suitable as the height difference between that and the crossing/bearer layout would be significant.

This is a temporary track panel that is constructed and taken to a renewal site that can be used to fill a gap where track has been removed but rail vehicles need to travel over the area of removed track. Once the required rail vehicle manoeuvres have been completed, the temporary slave panel is removed, and the new track installed.

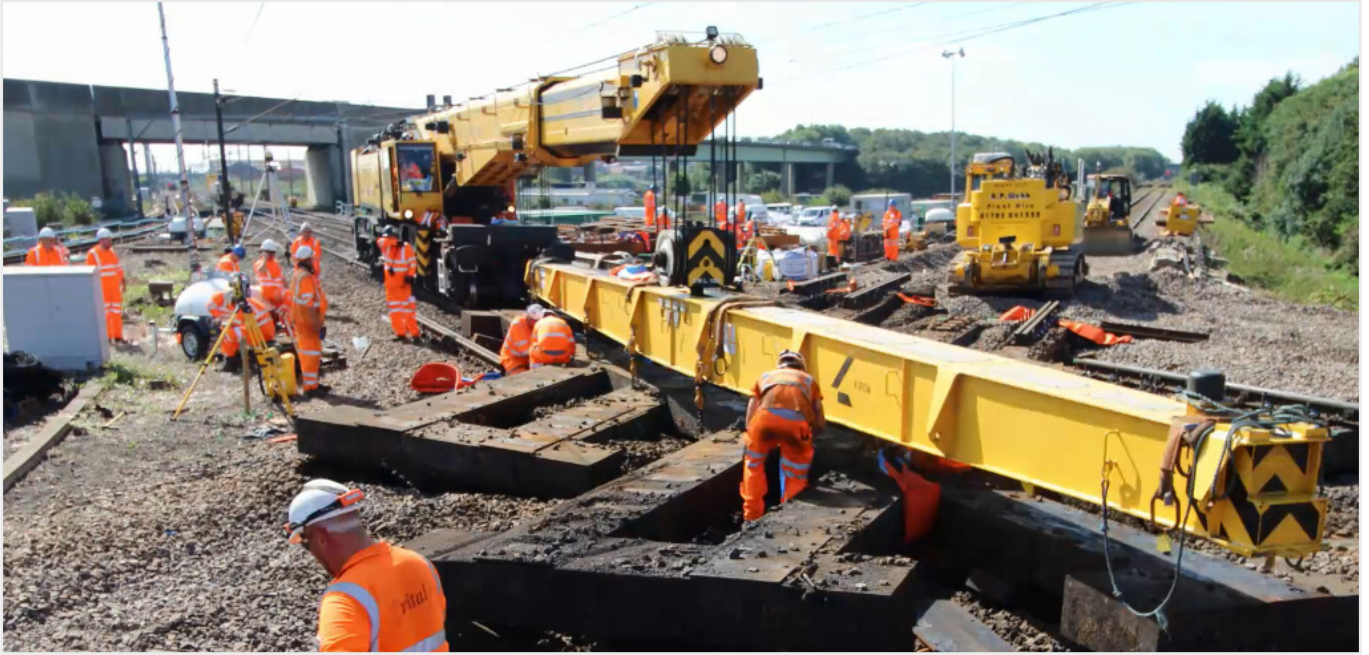
Image 13: One half of the old bearers being removed.

The 'old' crossings were removed and retained for use as maintenance spares before the bearer matrix was cut into two sections to make their removal easier (image 13).

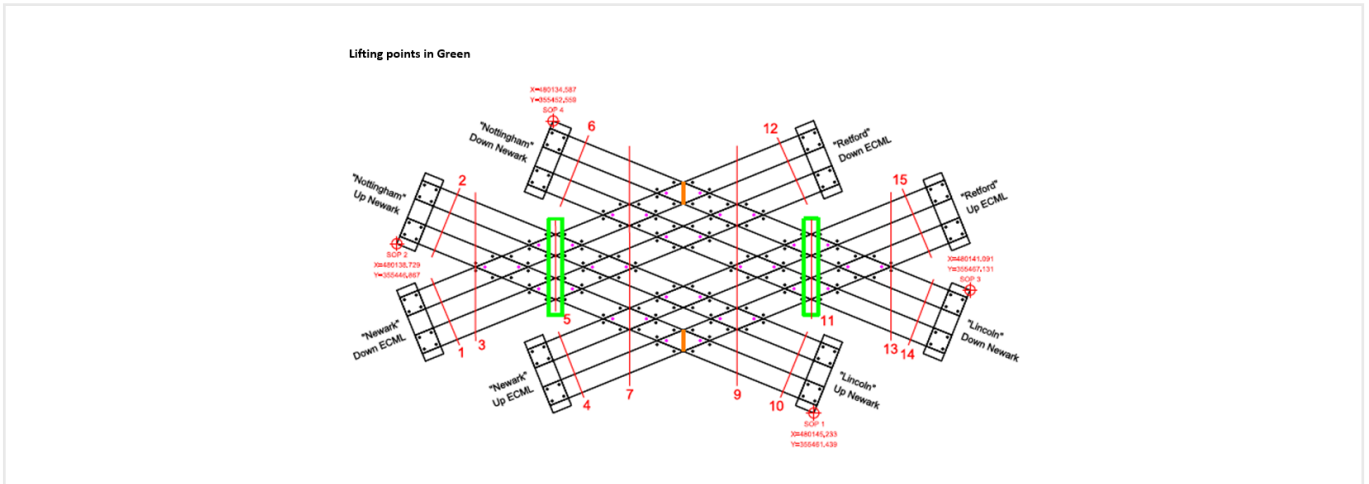
Figure 11: The layout lifting points.

This then raised the question of what stress would be placed on the components and would the FFU bearers be able to withstand these? Complex calculations were carried out to understand the values involved and if there was a risk of damage occurring to the FFU bearers. These considered the stress that would occur in the bearers alone. The addition of the stiffening effect of the crossings was not included in the calculations but it was taken into account that the 8 double star crossings fastened to the top of the bearers would significantly stiffen the whole structure. The calculations considering the bearers alone, confirmed there was a factor of safety of at least 2.5, but this would be greater when considering the effect of the crossings being in situ. The conclusion was that there was little risk of the FFU bearer assembly being damaged during the lifting operation.

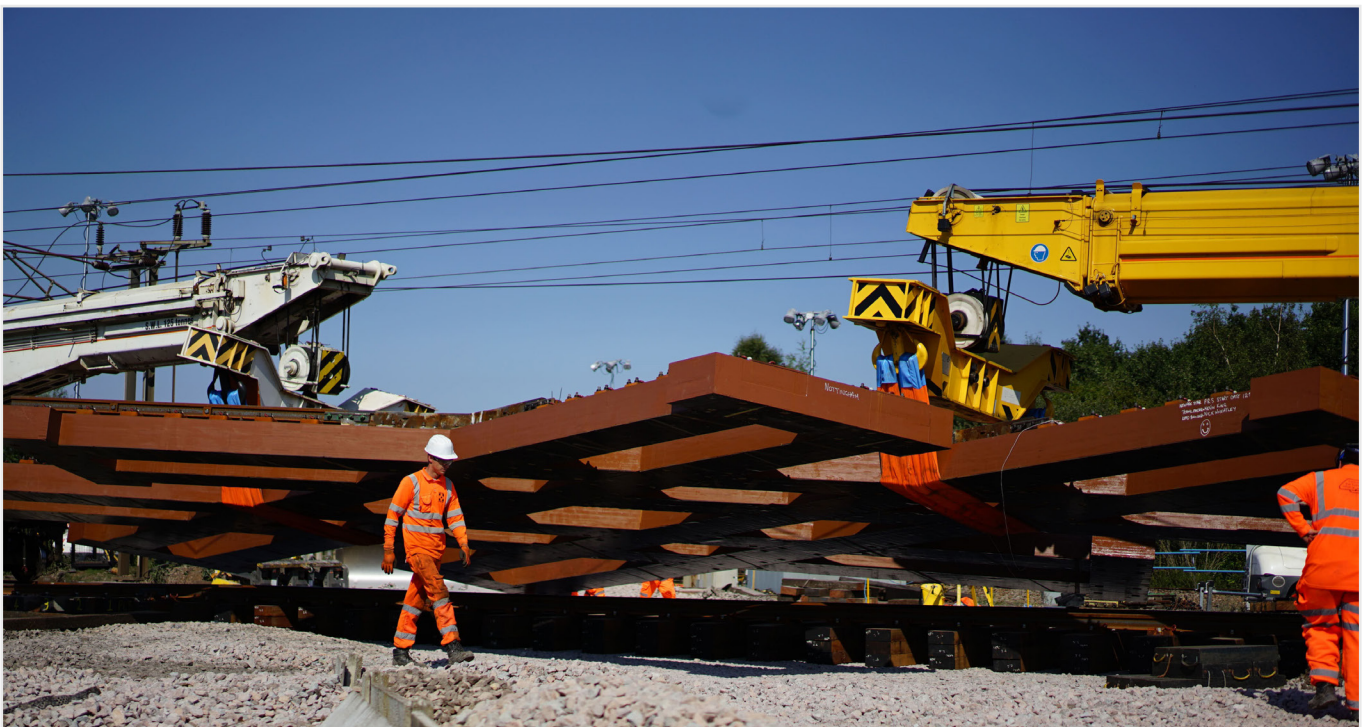
Image 14: The layout being moved to the holding area.

Fortunately, the layout was successfully moved, if in a rather ungainly way, to the holding area without further incident (see image 14). The layout needed to be placed in the holding area to allow a slave panel that allowed one of the cranes to pass over the 'hole' where the old layout had been to be removed. The layout was then lifted into place and then 'inched' into its final position.

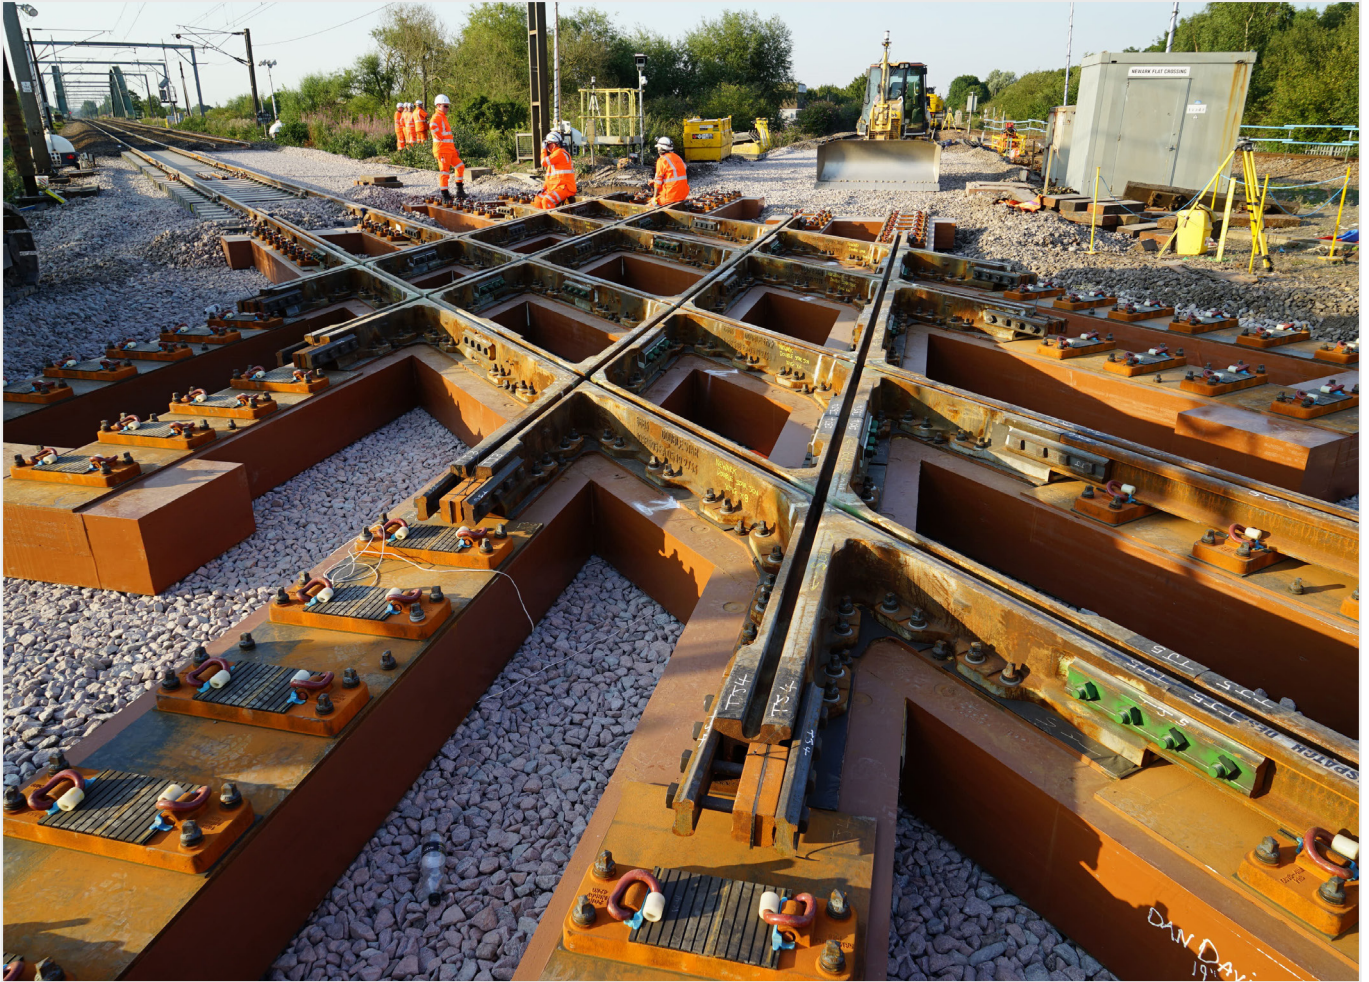
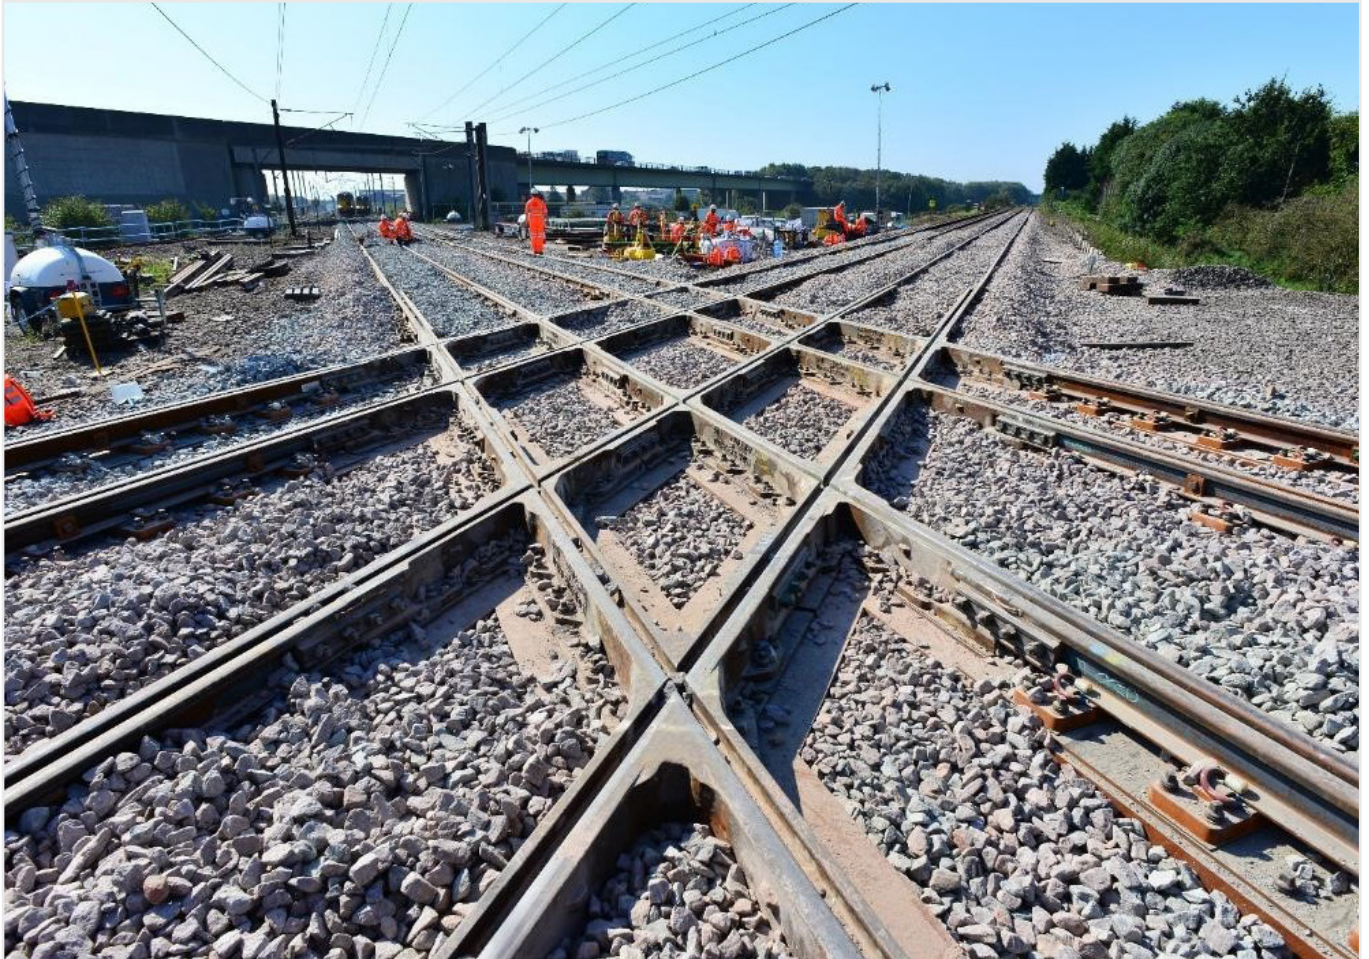
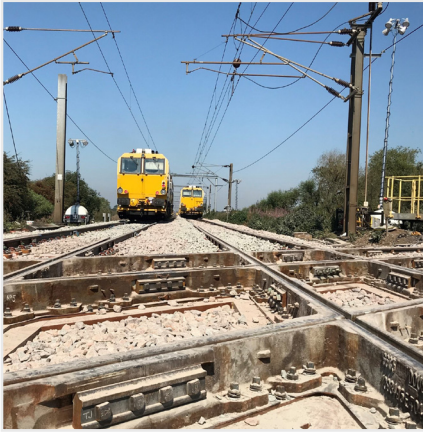
Image 15a (top): The layout in position. Image 15b (bottom): Tamping. Image 15c (next page, top left) Ready for handback.

Asking a Kirow crane driver to move the jib position a few millimetres here and a few millimetres there is quite a big ask. But after a bit of adjusting it was set in its final position (images 15a, 15b and 15c).
